**CHURCH OF ASH PRIORS, HOLY TRINITY.**  
**QUINQUENNIAL SURVEY.**

## QUINQUENNIAL SURVEY REPORT

| Name of Parish: | <b>ASH PRIORS</b> | | |
| Date of Survey: | July 2010 | | |

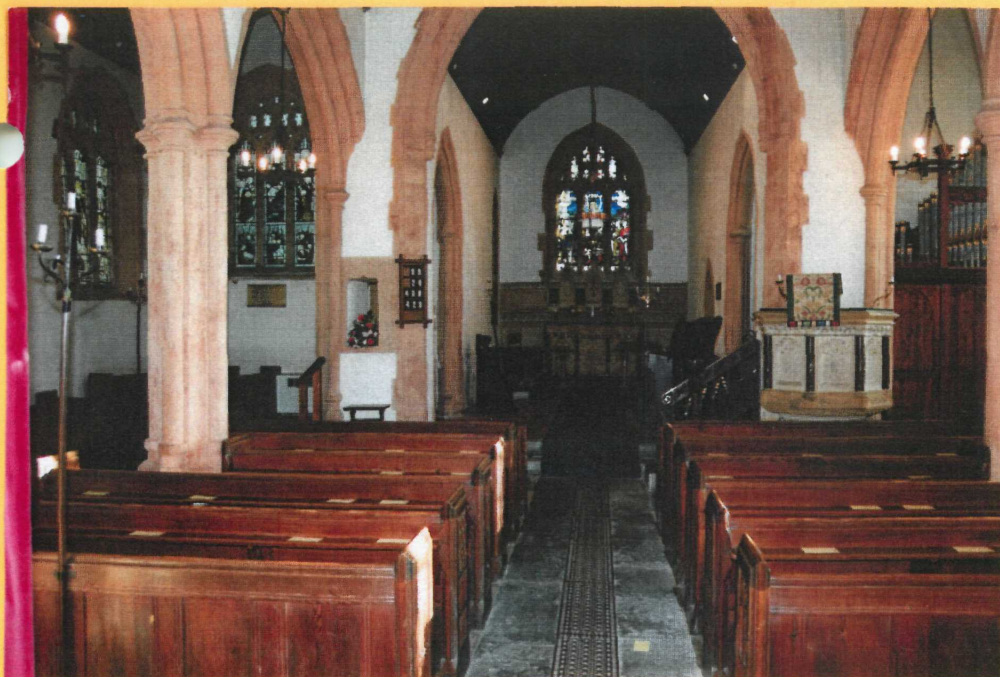
1. Nave, Chancel -  
Looking East.

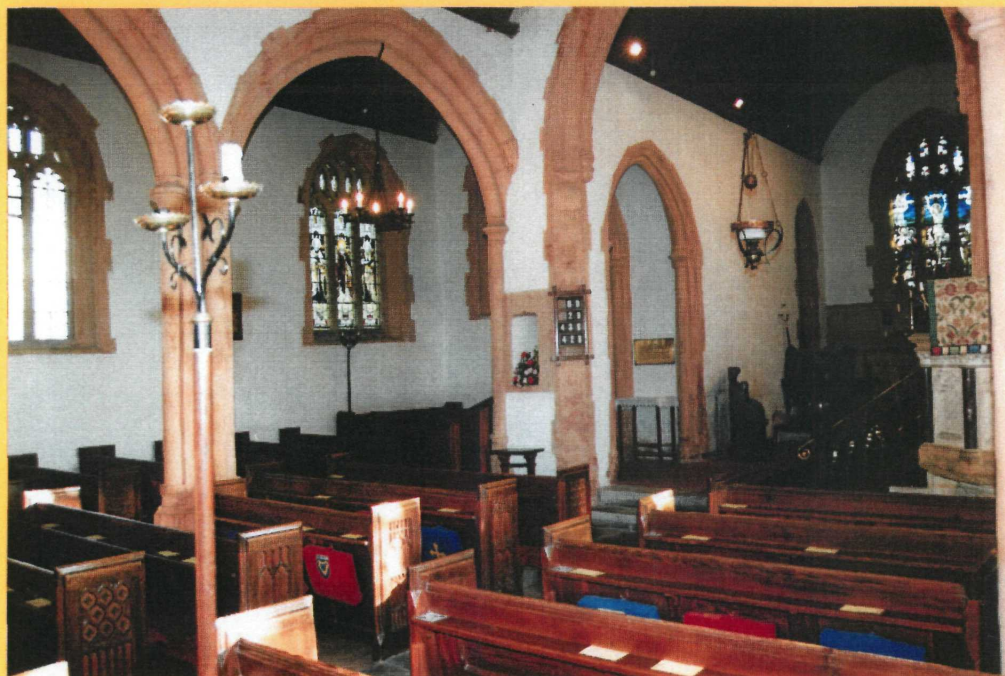
2. Nave, Chancel &  
North Aisle.

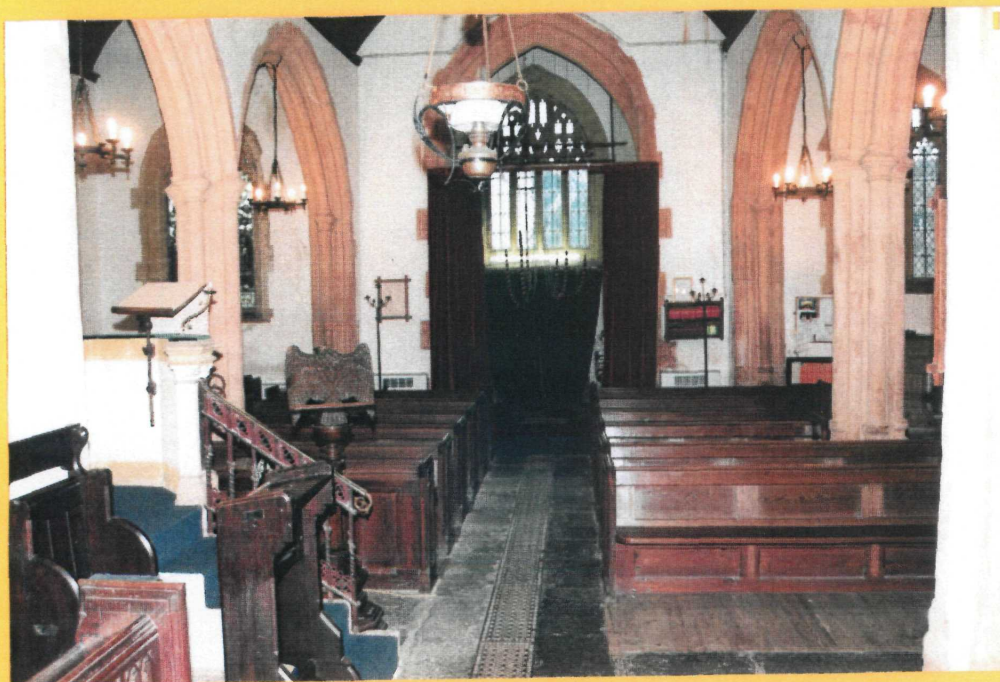
3. Nave & Tower  
Arch. Looking West.
